SWAMPSCOTT PIER PROJECT

HARBOR & WATERFRONT ADVISORY COMMITTEE

February 3, 2022 update March 3, 2022

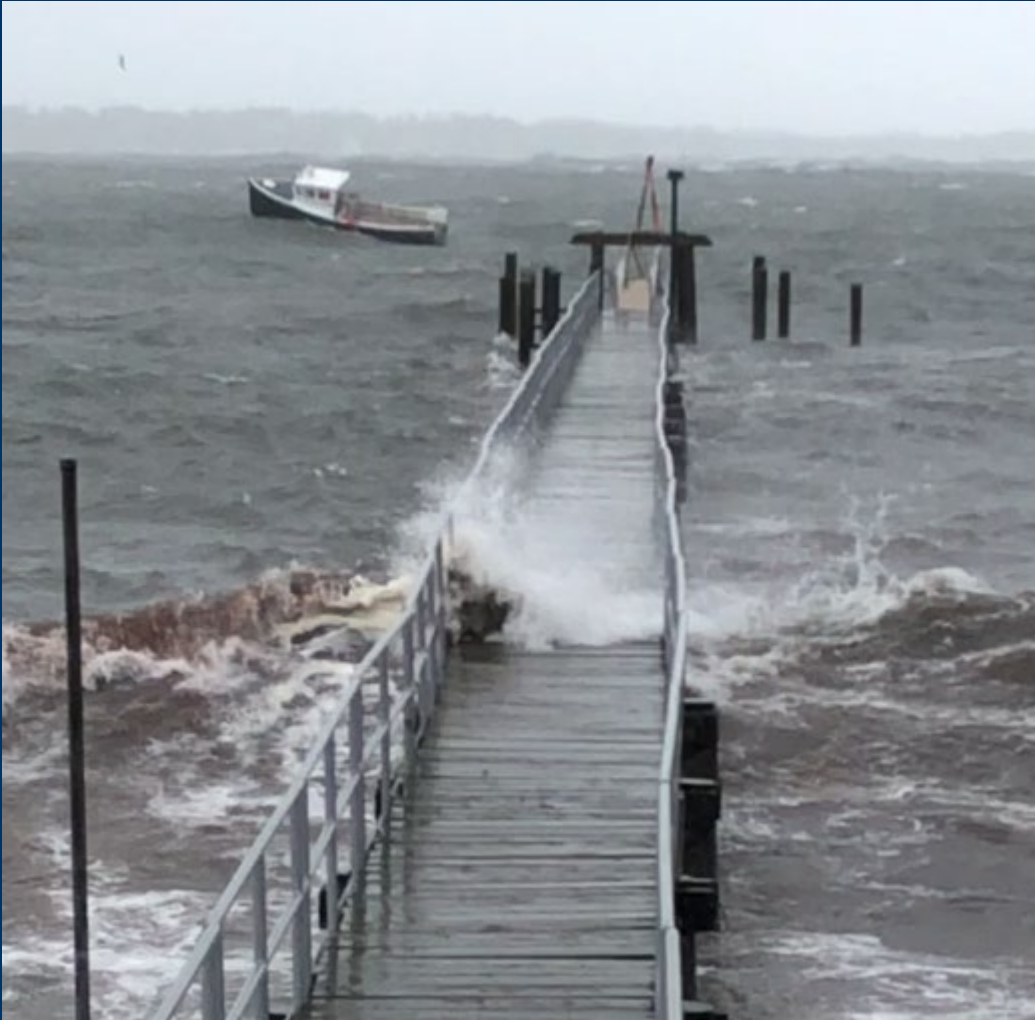
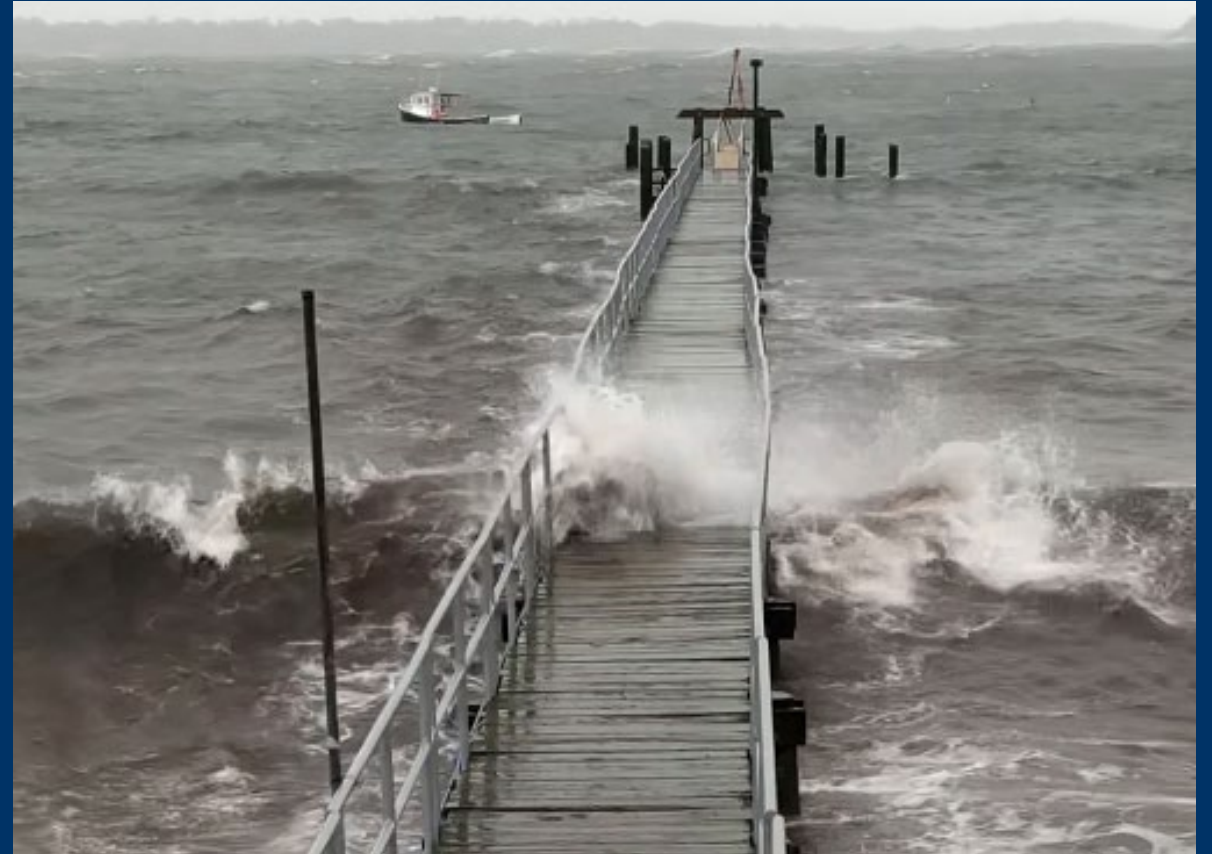
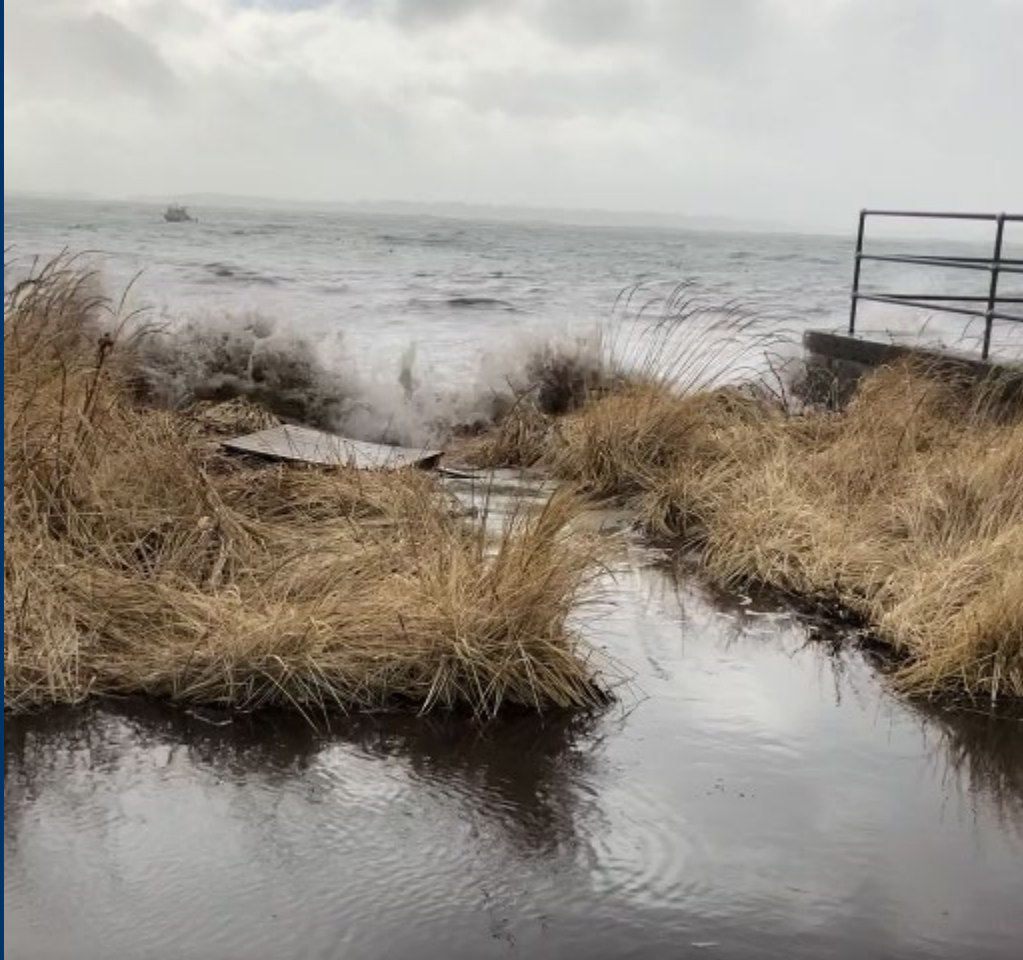
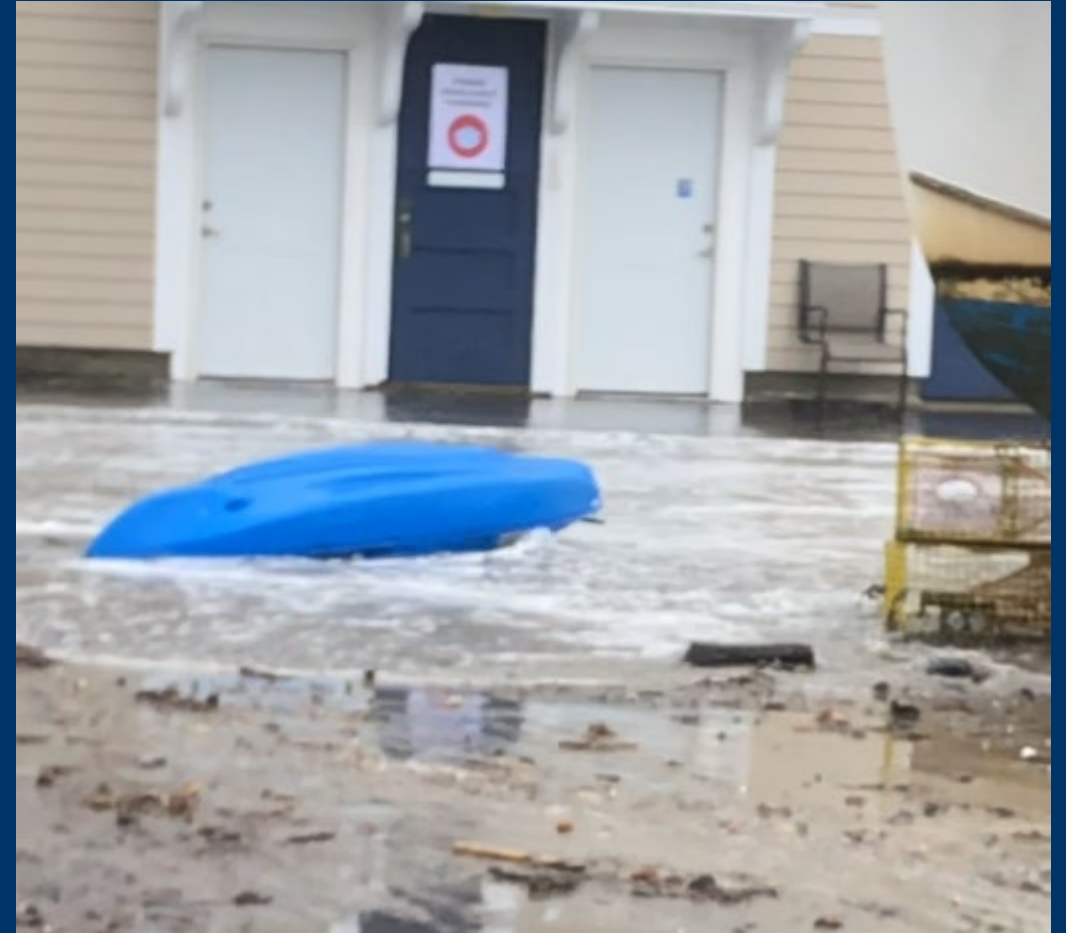
January 17th Storm Event

- What we heard at the last meeting:
 - Dredging of the harbor is most important to the Fishermen
 - Concerns about splitting up the beach by constructing pier to the west, maintaining connection between Fish House and Pier
- Big Storm Event on 1/17
- Round 1 Geotech Soil Sampling Occurred on 1/18
- Group Meeting with Regulators – 1/11/22 – EPA, MA DEP, MEPA, DMF, CZM
 - Primarily Related to Eelgrass Concerns

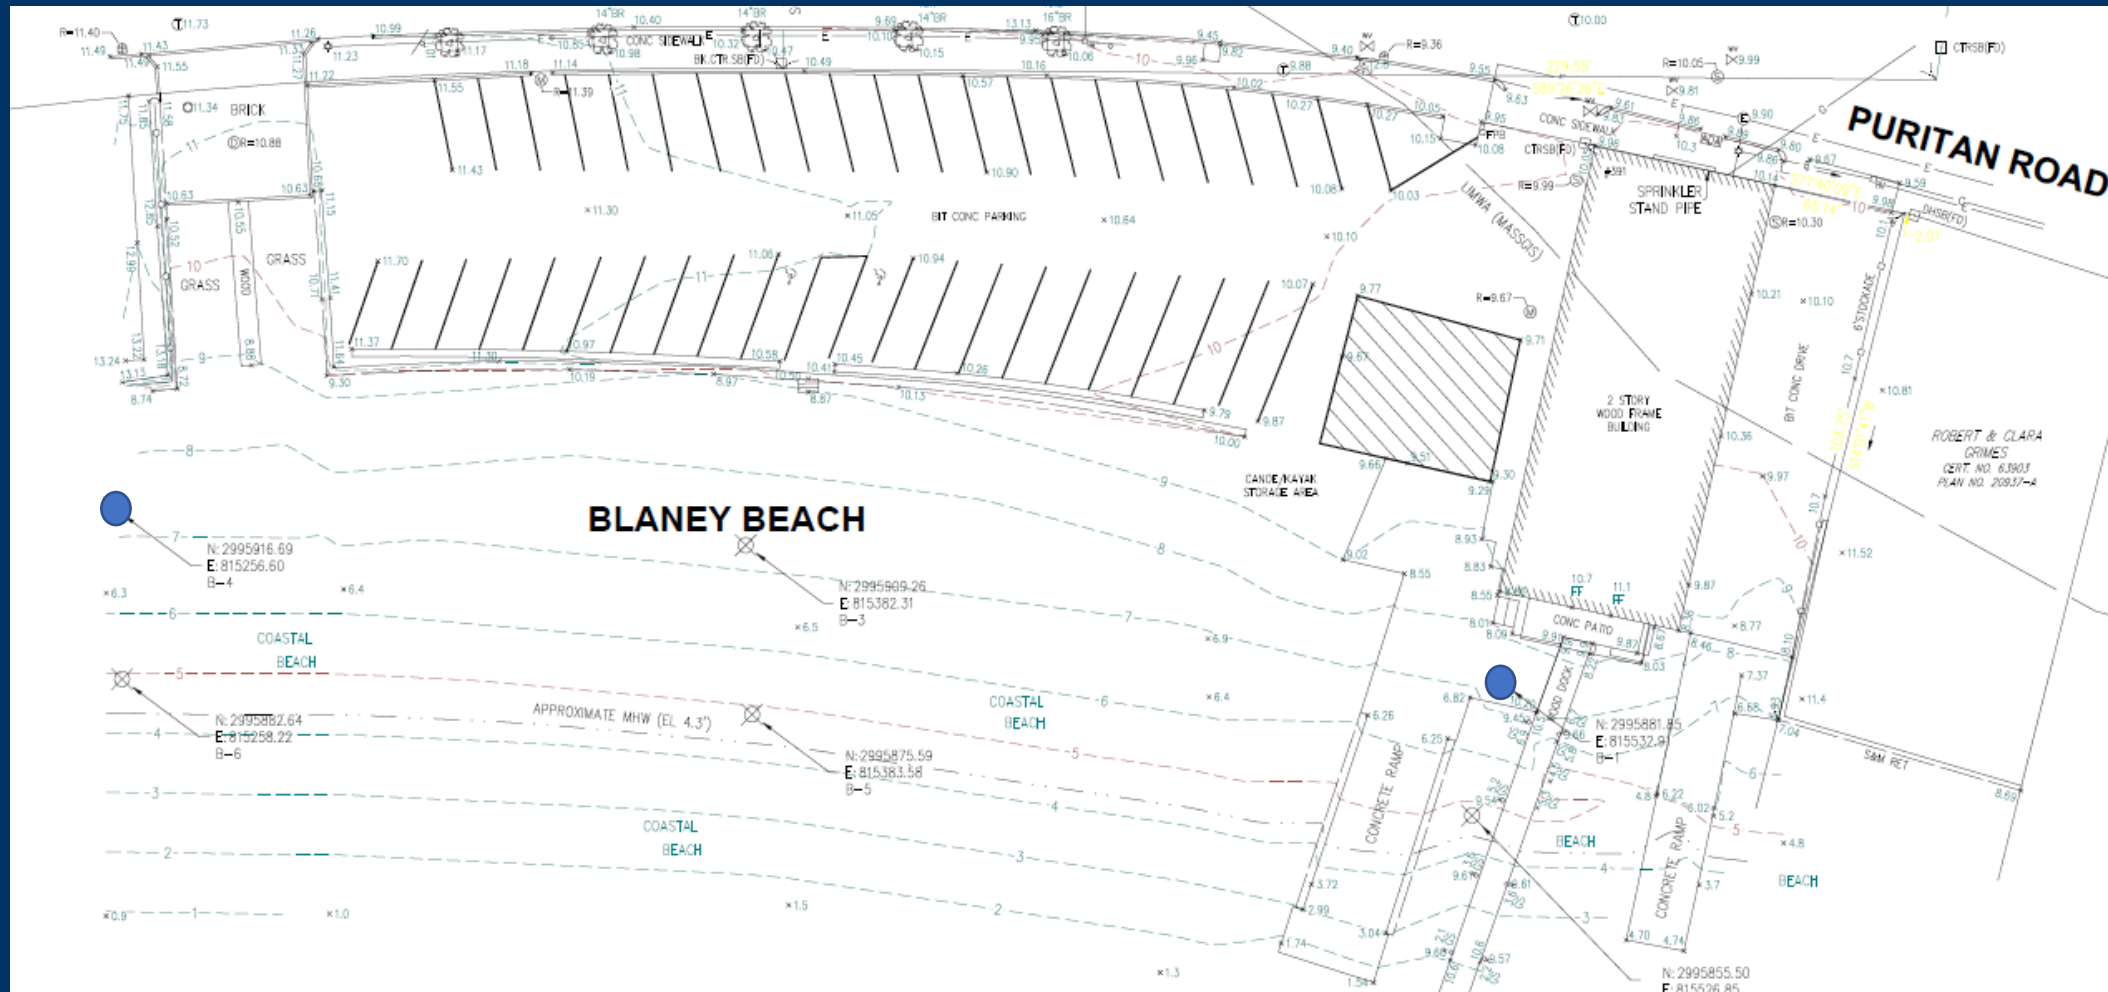
Round 1 Geotech Boring Program

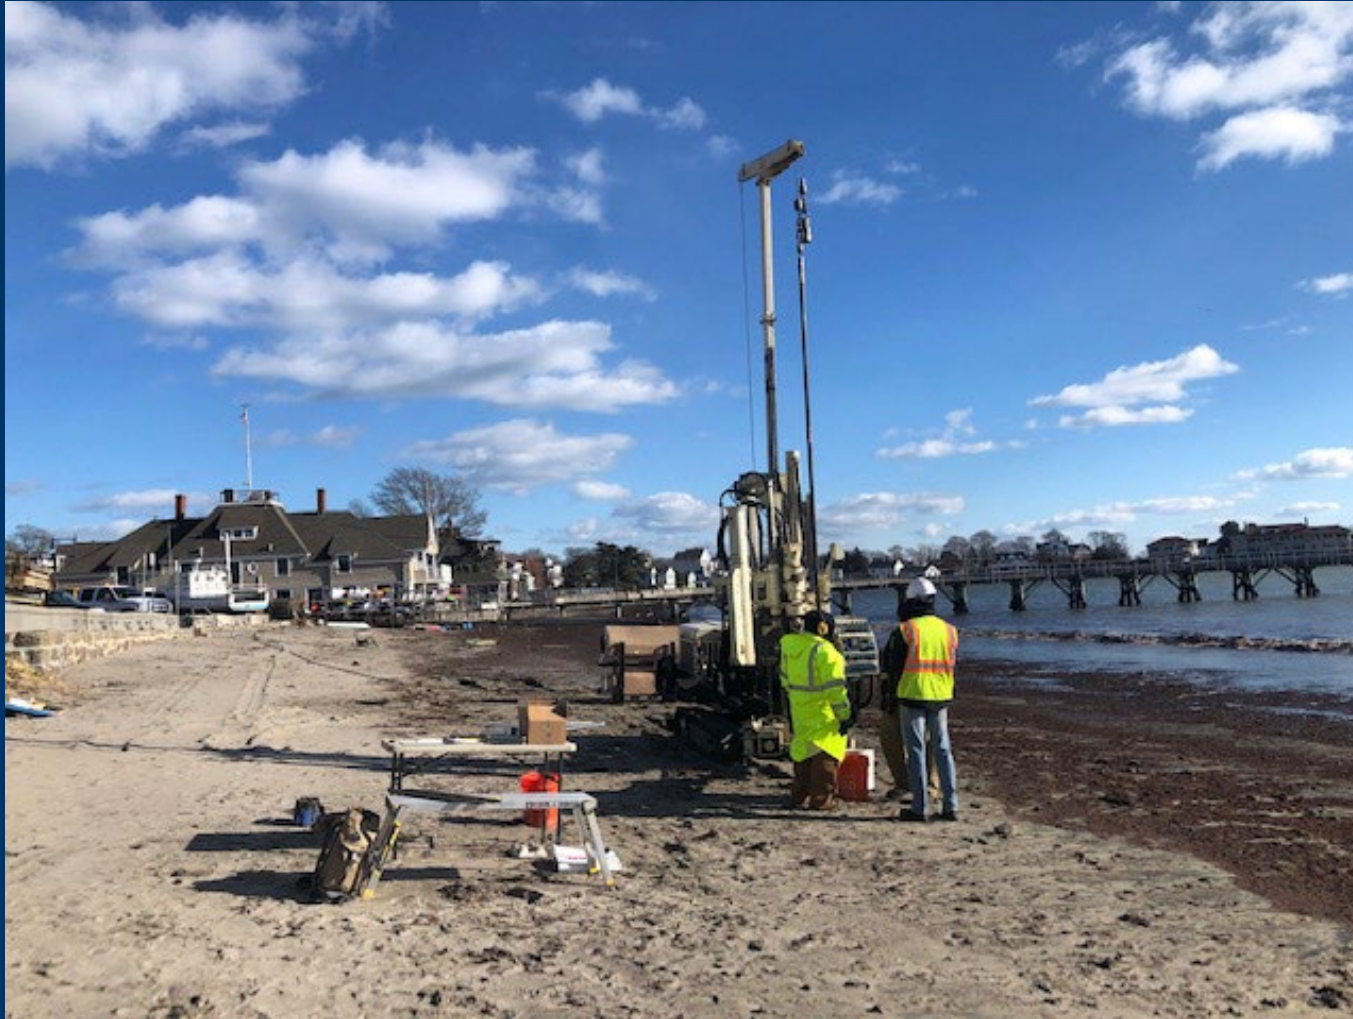
Boring Program

2 Boreholes- Similar profiles:

- 10-12 ft – Sand
- 15-17 ft – Med to stiff clay (one layer of soft clay)
- No refusal to 27 ft below grade – Bedrock not Encountered
- Typical Peri-glacial Subsurface Conditions

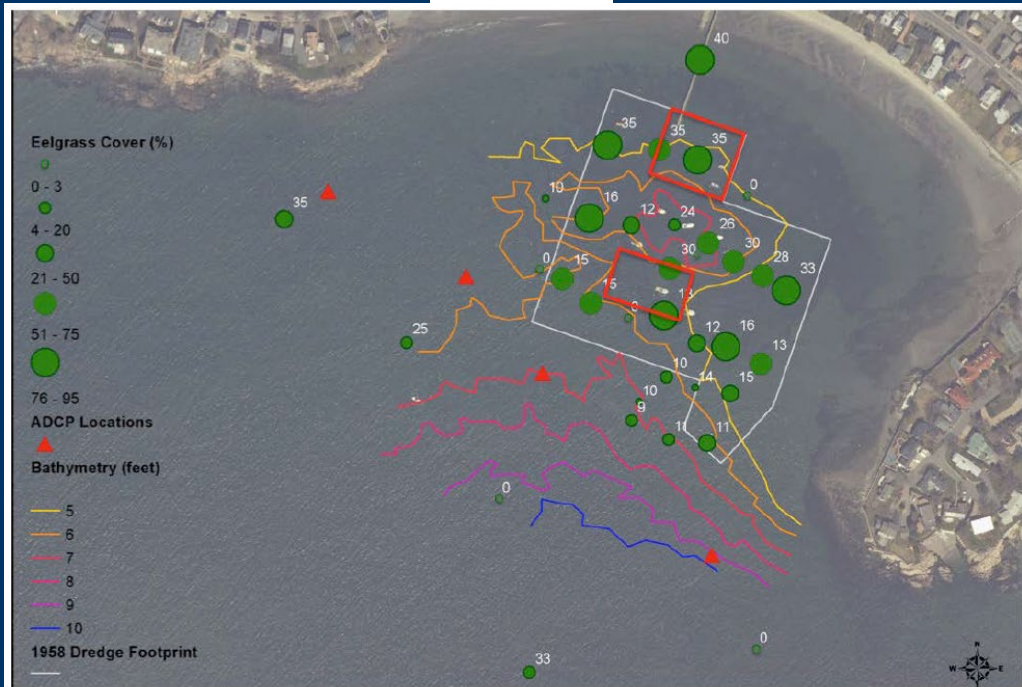
Figure 7. Alternative #4, the Reduced Impact Plan, showing the boat mooring area outlined in red, inside the 1958 Dredge Area. Alternative #4 reduces the impact to eelgrass by dredging smaller areas in the shallowest parts of the mooring area.

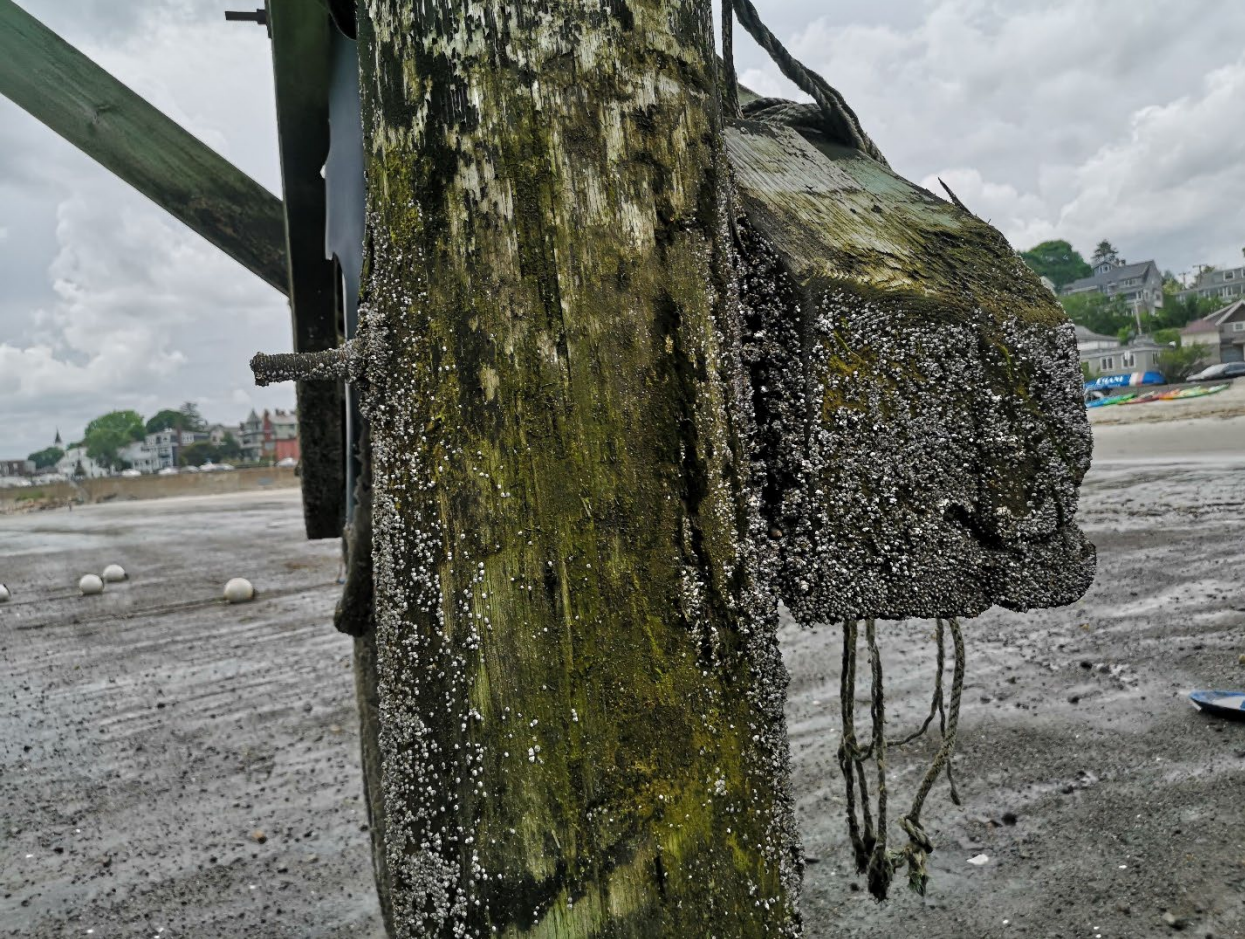
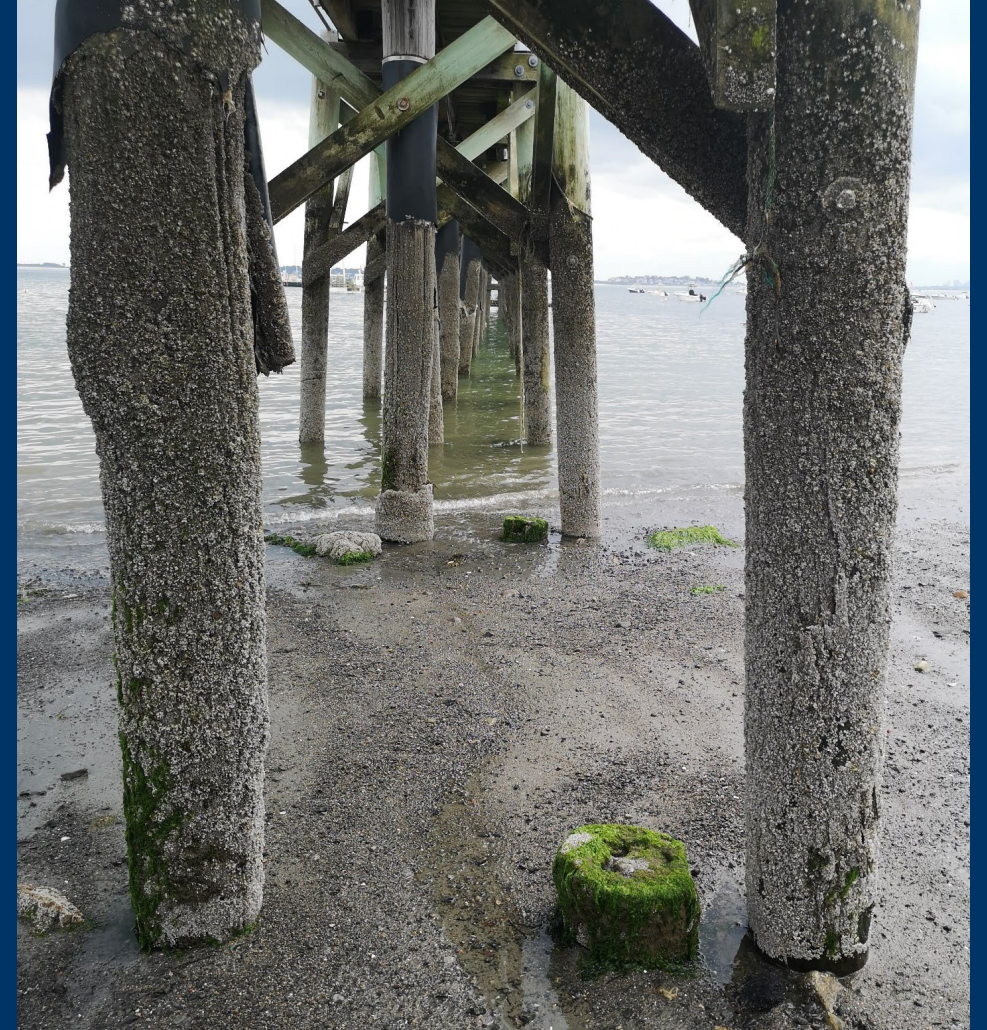
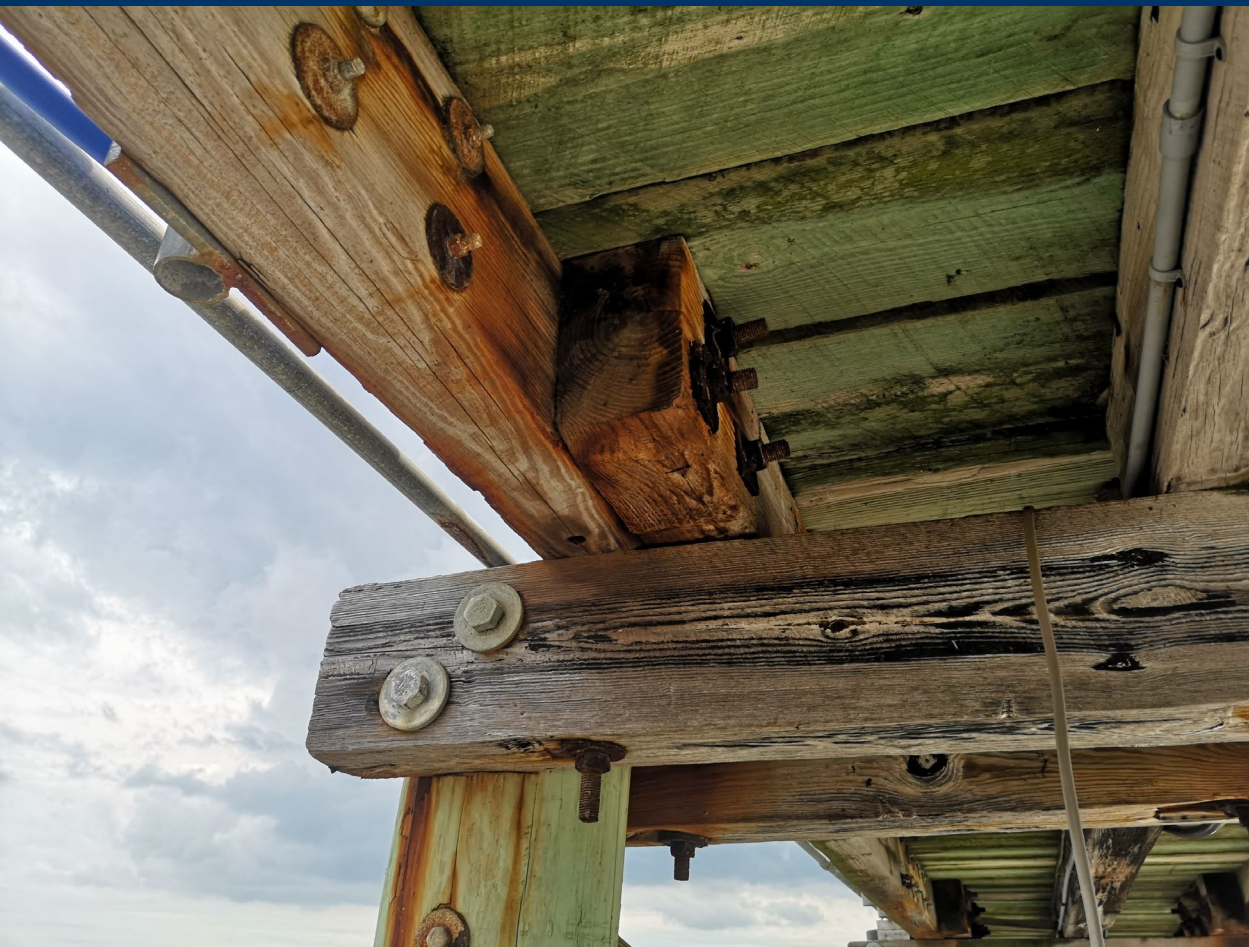
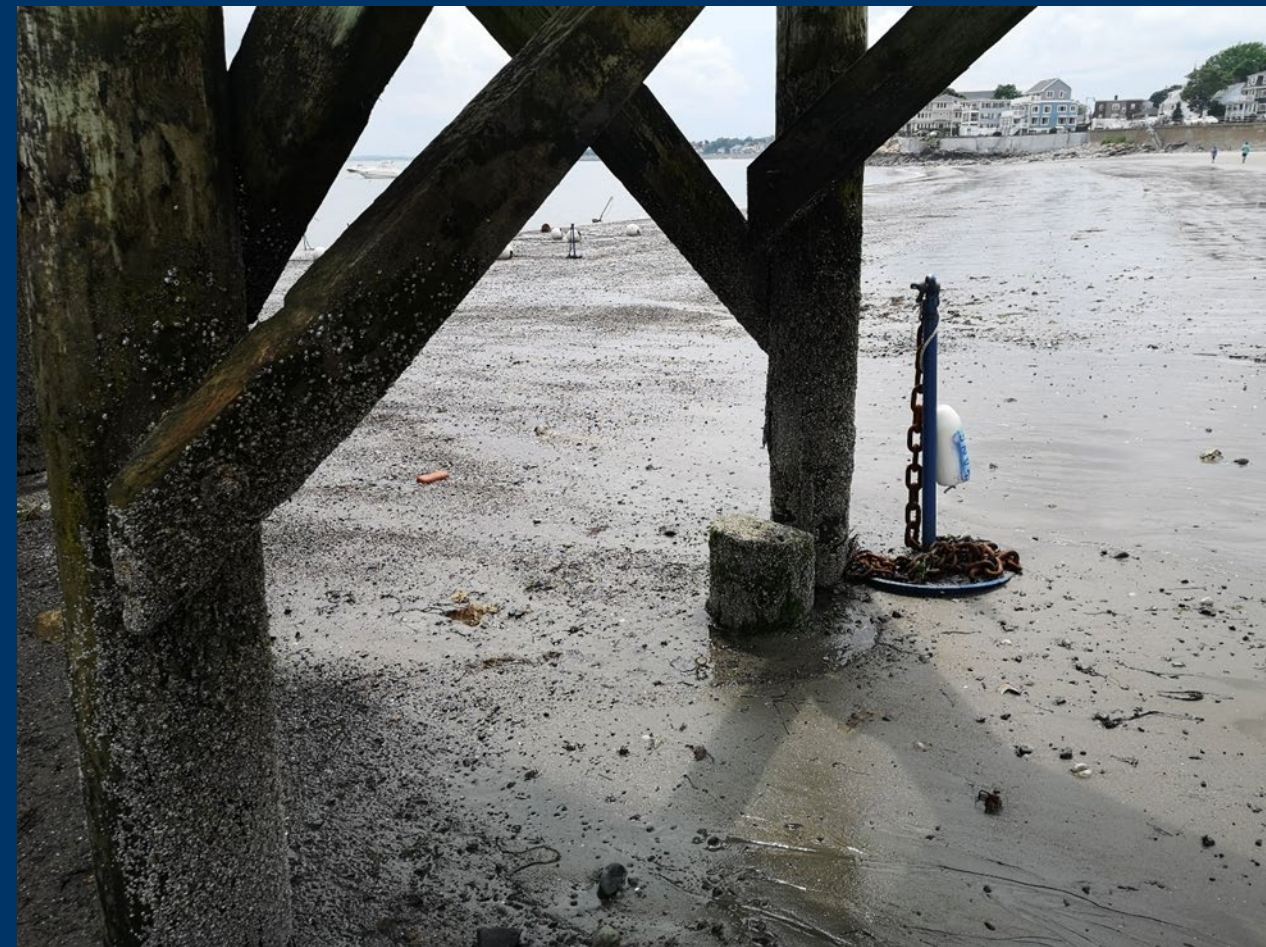
Existing Structure

A complete structural assessment (consistent with the ASCE Waterfront Facilities Assessment Manual), has not been completed, However, we have performed above water and intertidal area documentation

- Timber Structure – Completed in 1961 – 61 years old
 - Original Design Life would have been indicated in original design report- Unavailable
 - Typical Design Life for Timber Pile Supported Marine Structures – 50 yrs
 - Does not mean Structure is unsafe or structurally unsound after 50 yrs
 - Structure needs to be inspected, monitored and maintained
 - Balance of replacement cost versus continual maintenance costs
- Timber is a non-homogenous material, and can weather and age differently within the same structure
 - Need to look at Piles, Caps, Stringers, Braces, Deck, and mudline
 - Review over time, baseline inspection versus subsequent inspections

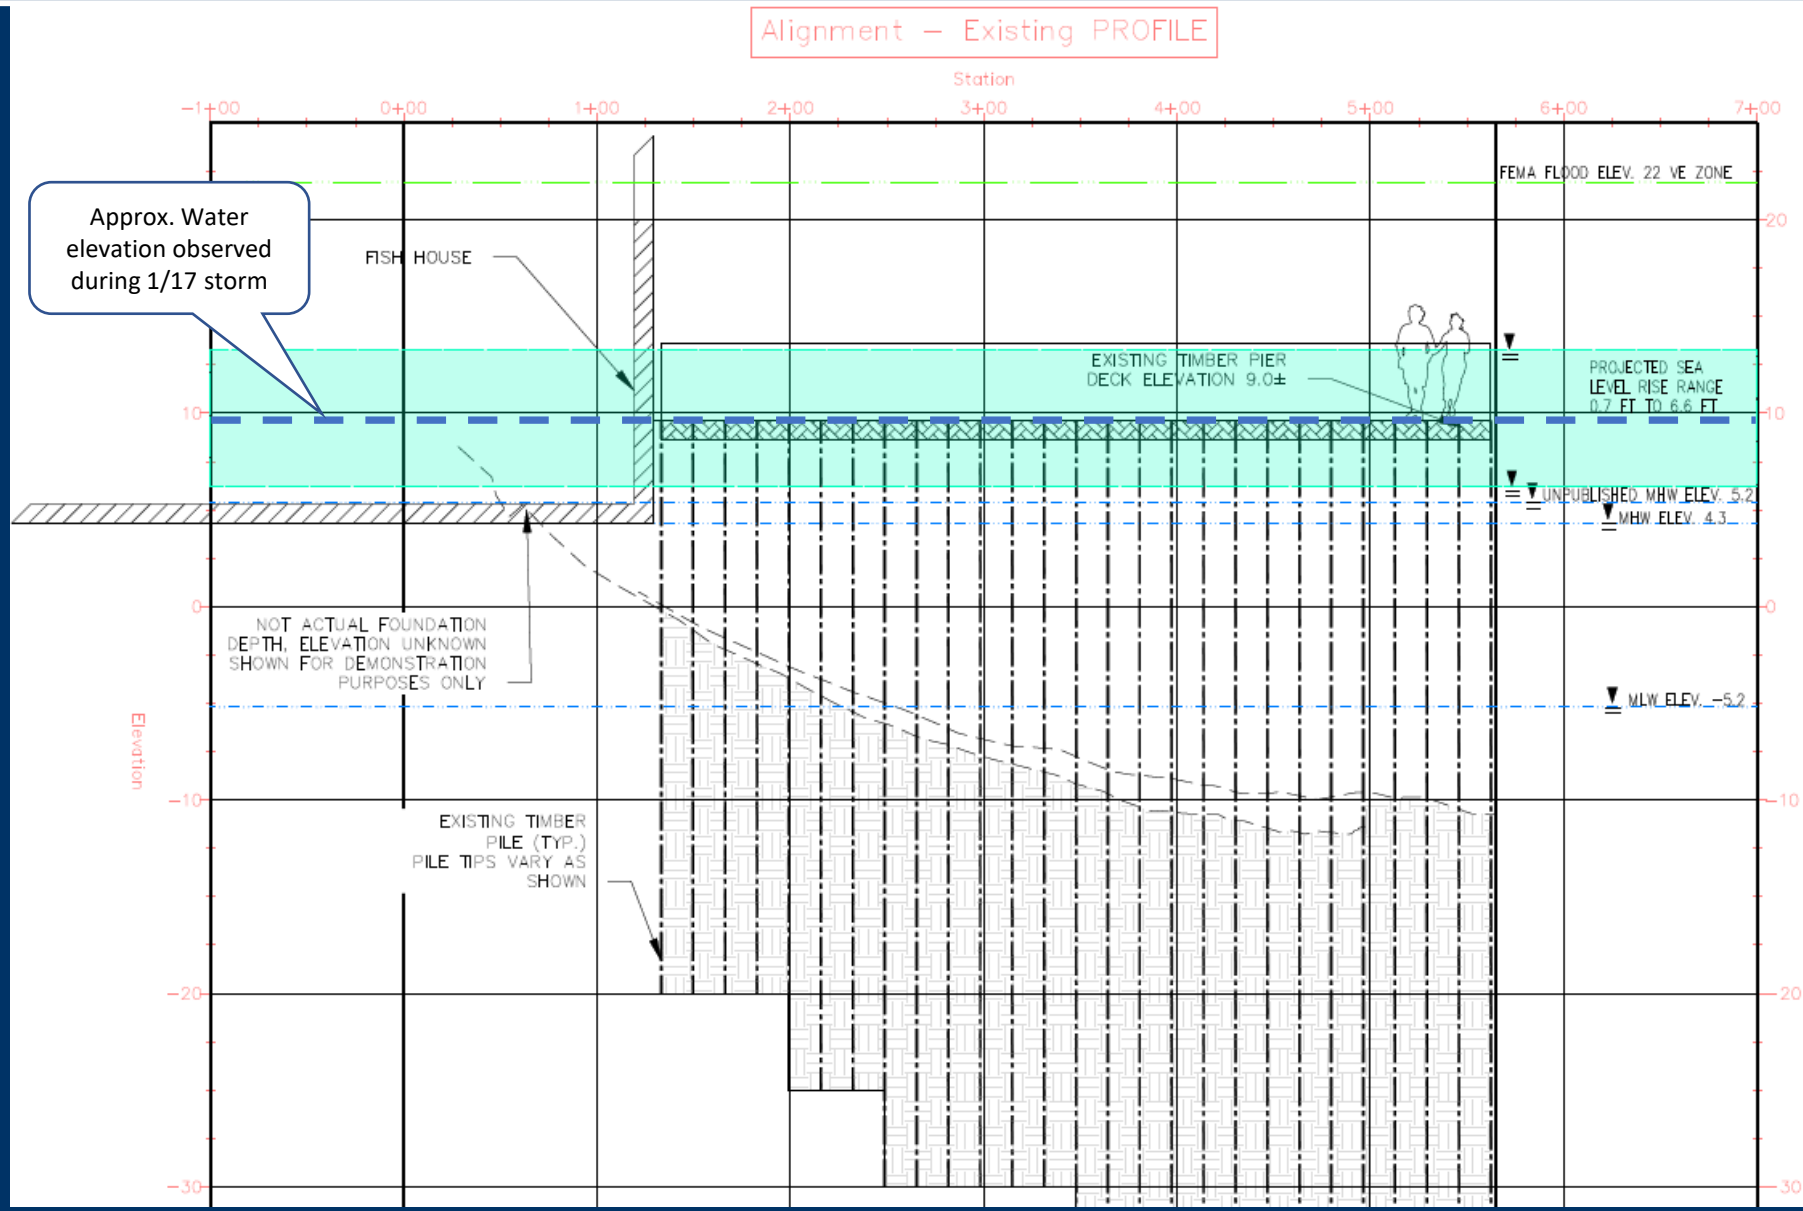
Structure Height
