**SUBJECT: Consent Decree Compliance Report
Period 8/1/2016 to 1/31/2017**

**SUBJECT: COMPLIANCE REPORTING - CASE 1:15-CV-13388-DJC
SWAMPSCOTT, MASSACHUSETTS**

Reporting Period: August 1, 2016 through January 31, 2017

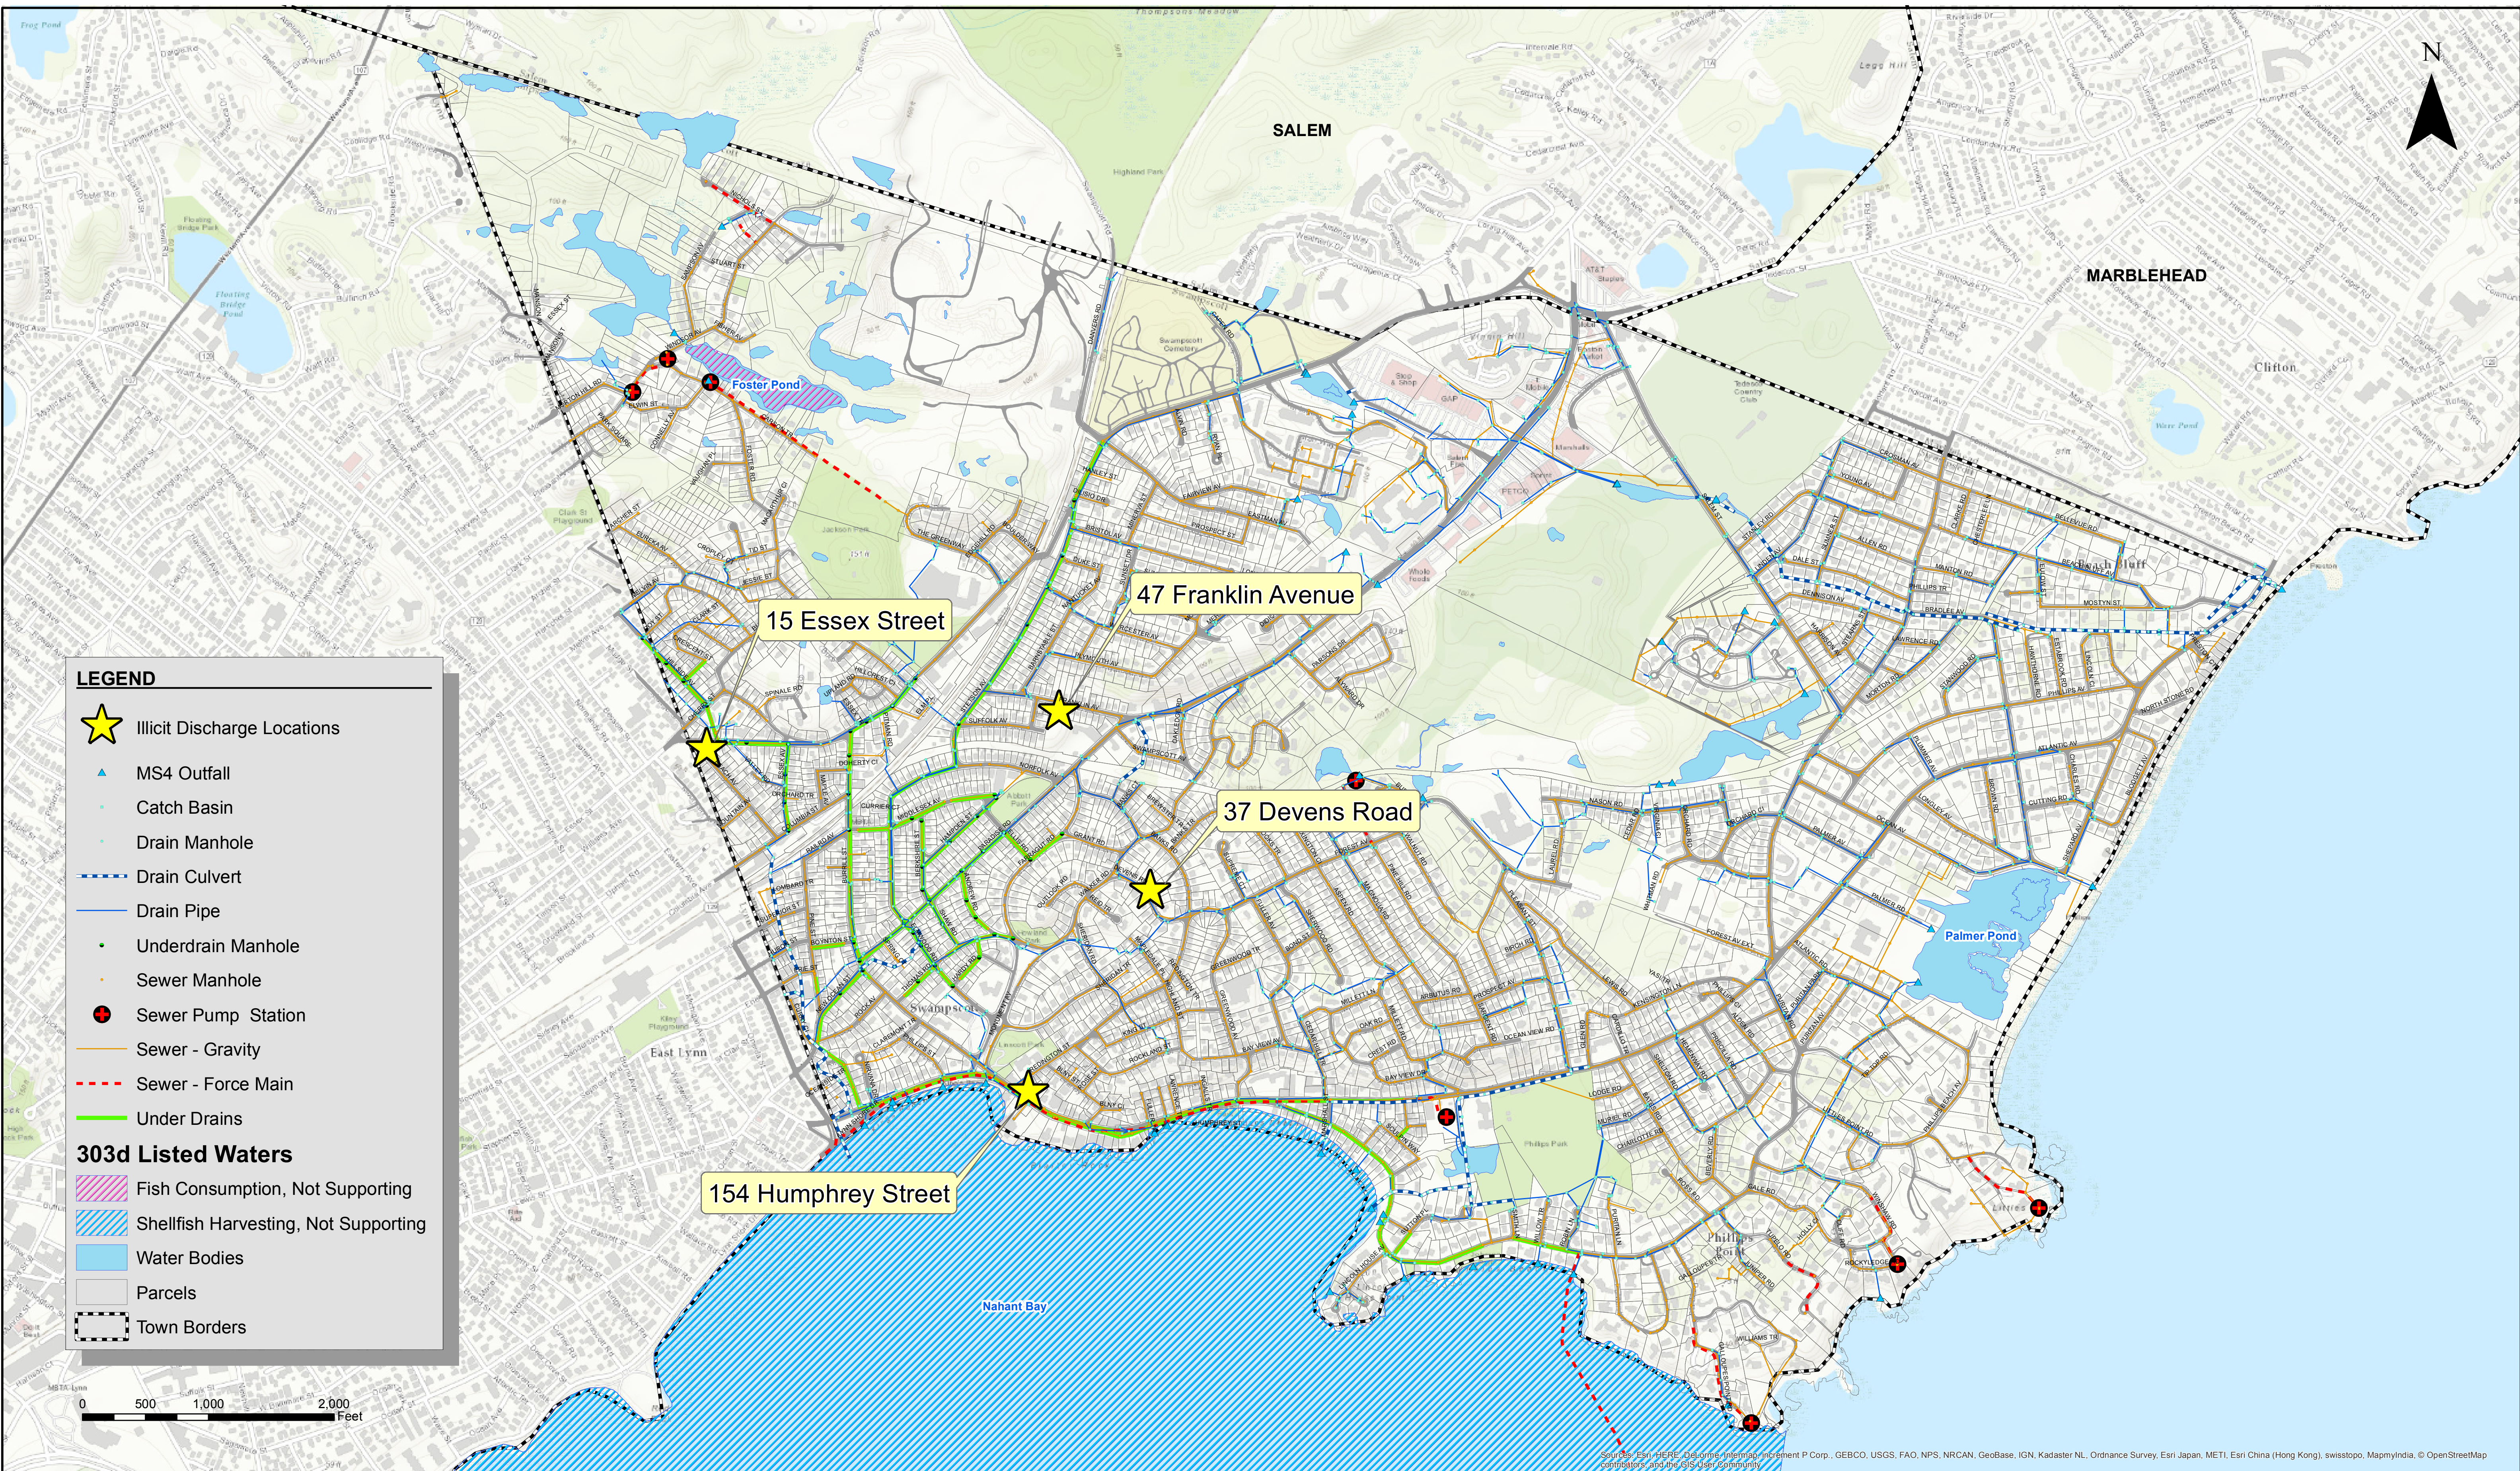
Map of Illicit Discharge Locations
During Reporting Period

Illicit discharges reported in Section d) are illustrated on the map in Attachment A. No SSOs were reported during this reporting period.

Illicit discharges reported in Section d) are illustrated on the map in Attachment A.
