SUBJECT: Consent Decree Compliance Report
Period 2/1/2022 to 7/31/2022

**SUBJECT: COMPLIANCE REPORTING - CASE 1:15-CV-13388-DJC
SWAMPSCOTT, MASSACHUSETTS**

APPENDIX A
ILLICIT DISCHARGE & SSO LOCATIONS
REPORTING PERIOD: 2/1/22 TO 7/31/22

EPA Consent Decree
 Swampscoot, Massachusetts

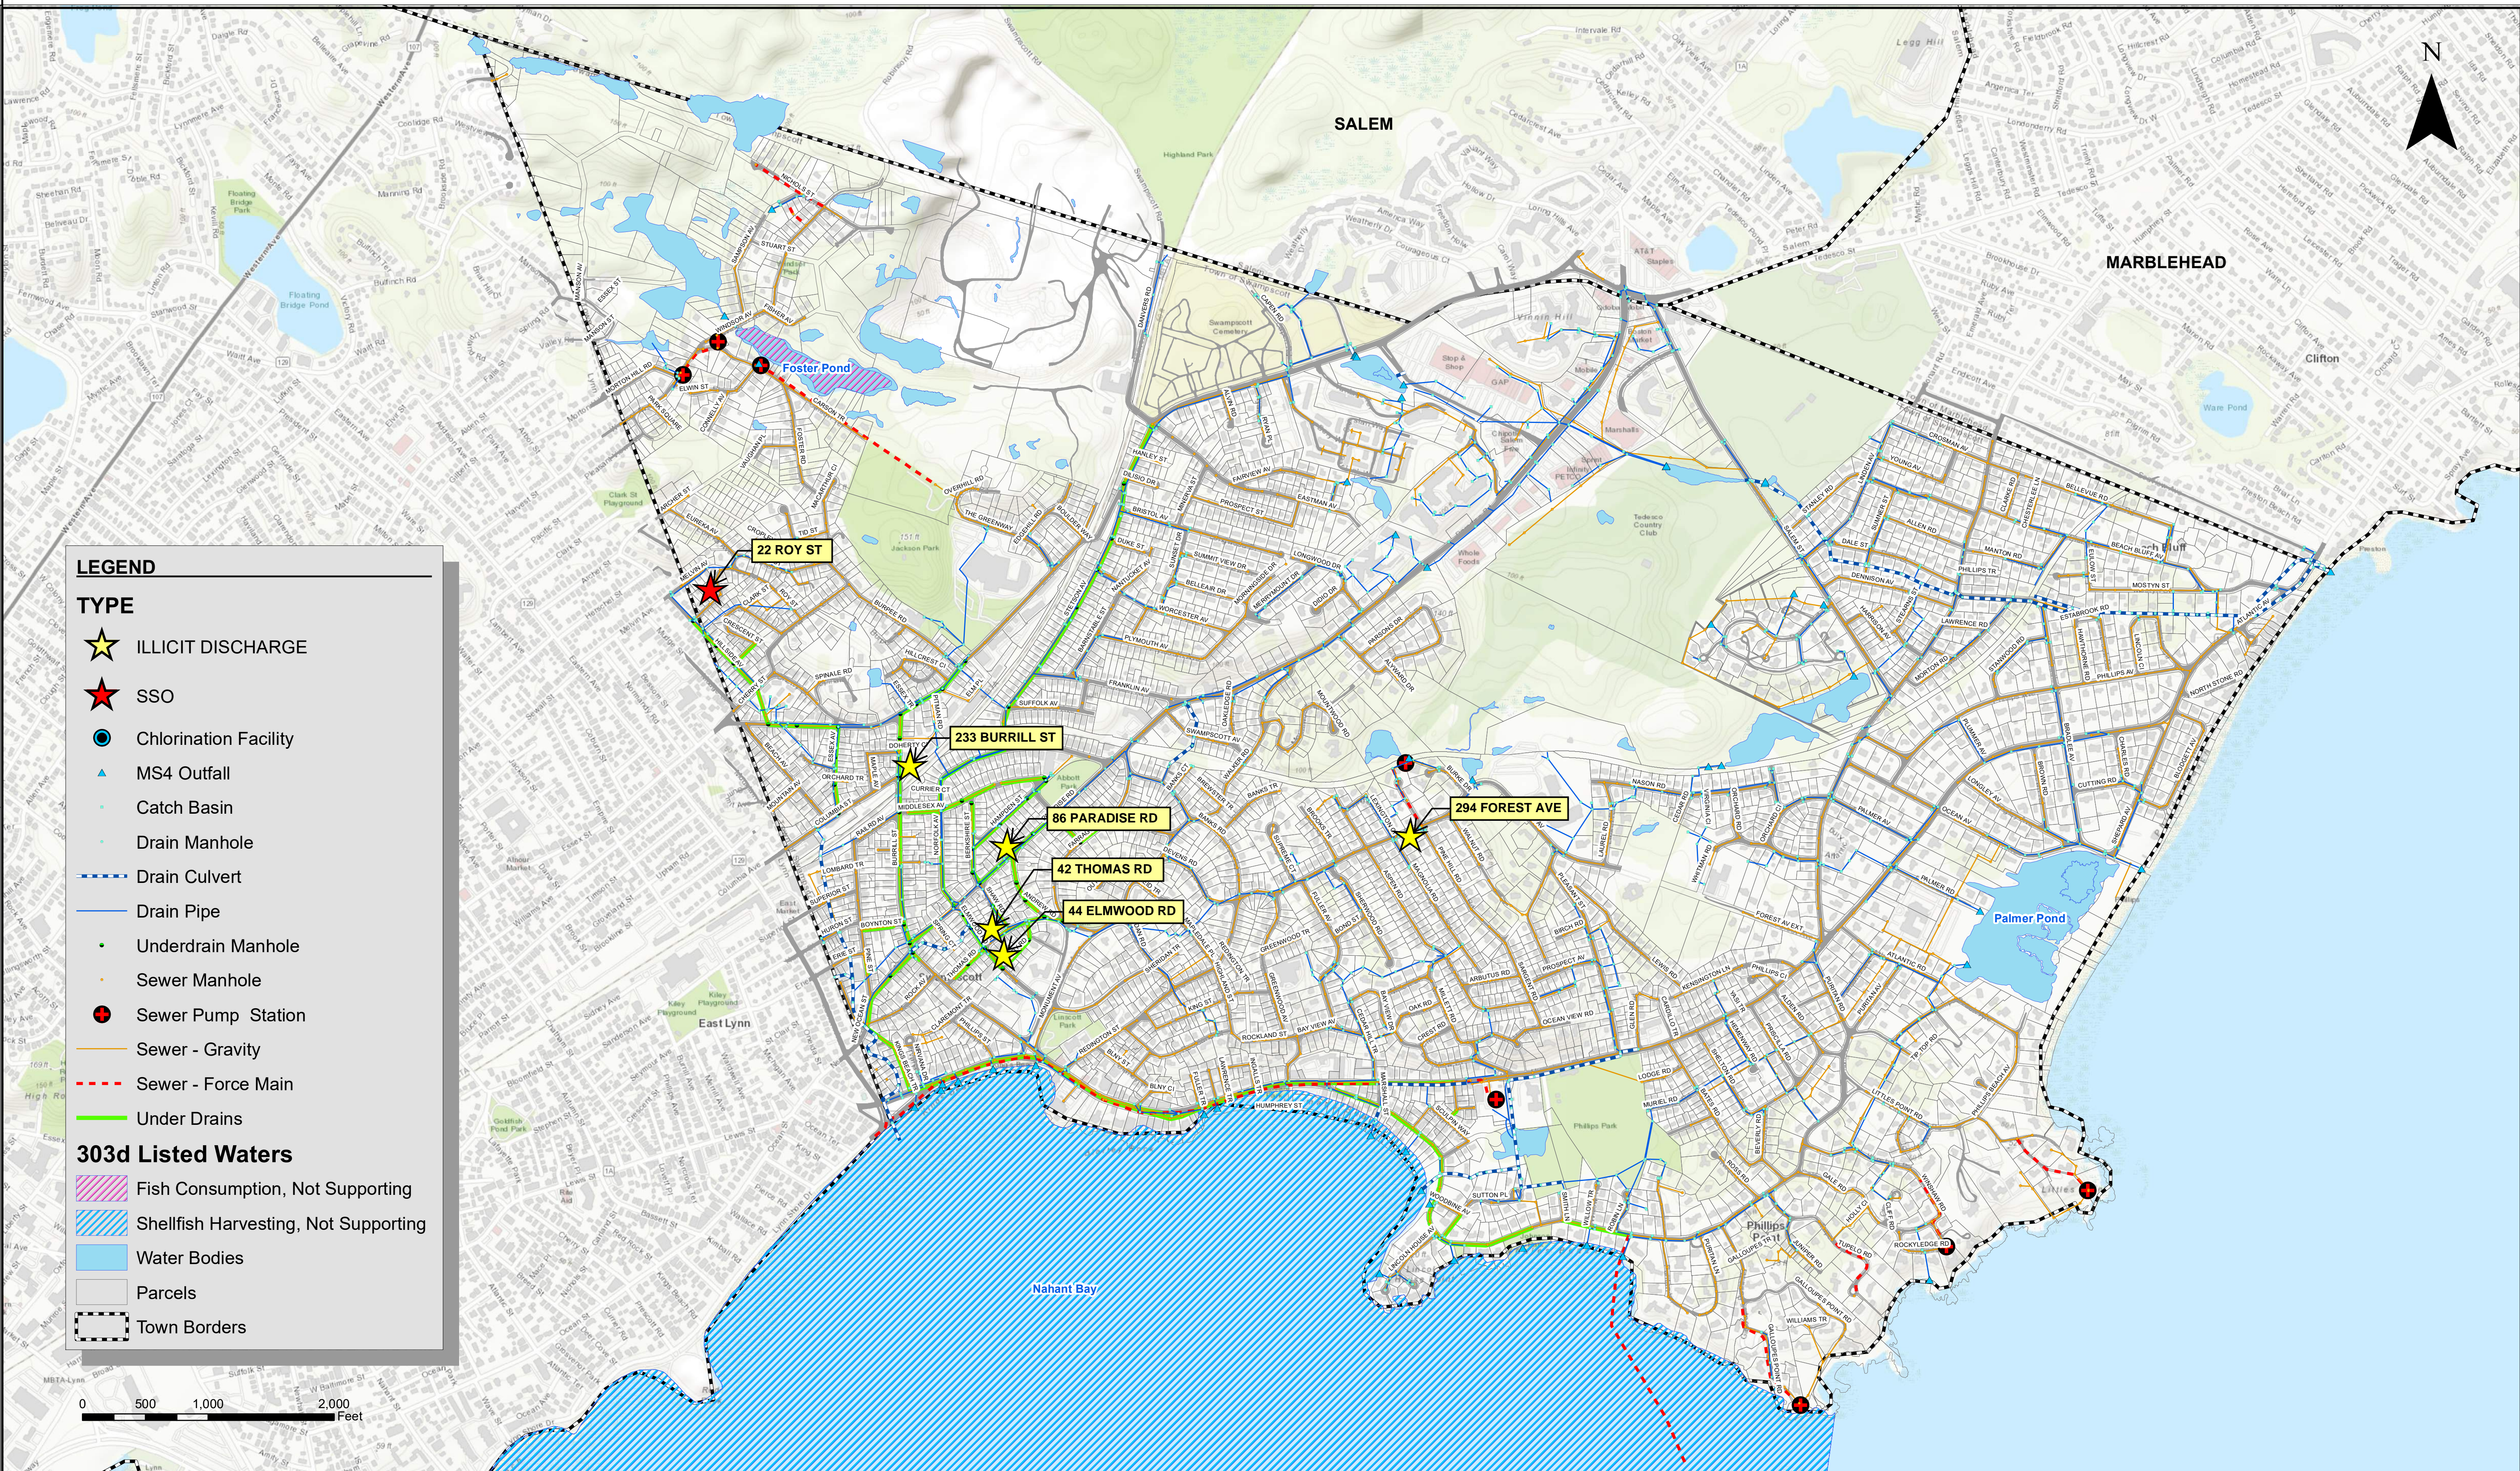
SSO and Illicit Discharge Map

A map displaying the location of the SSO events that occurred during the current reporting period is included in **Appendix A**.

A map showing the locations of all illicit discharges and SSOs is included in **Appendix A**.
